# **COATED-FABRIC TANK LIFE EXTENSION STUDIES**

## **INTERIM REPORT TFLRF No. 312**

**G.E. Fodor  
U.S. Army TARDEC Fuels and Lubricants Research Facility (SwRI)  
Southwest Research Institute  
San Antonio, Texas**

May 1996

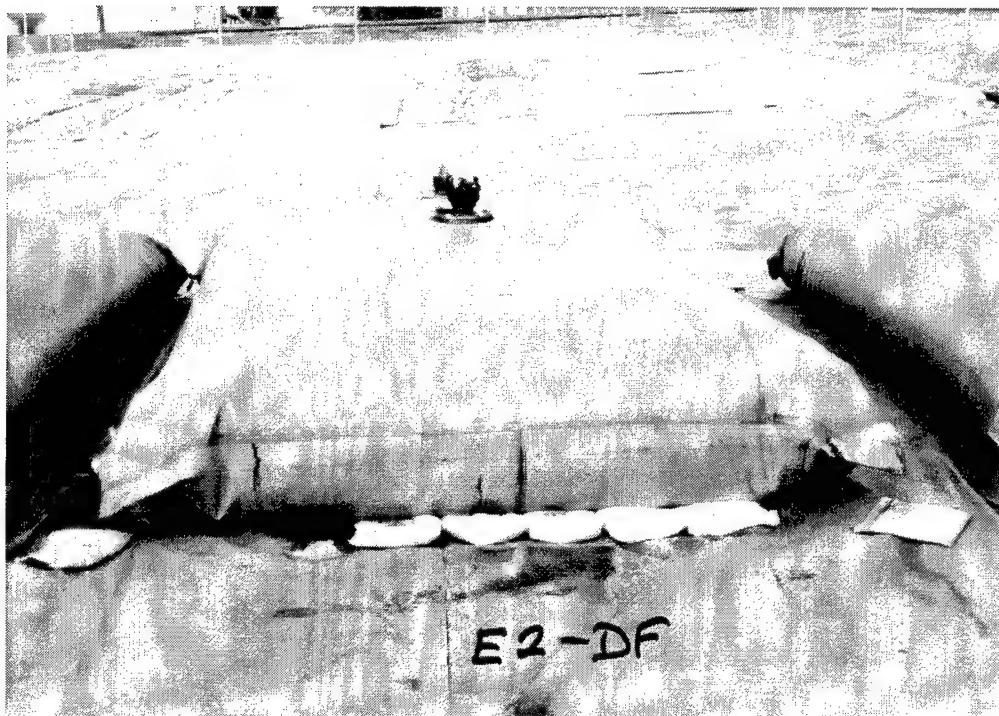
and environmental hazards, the tank was surrounded by "Hazorb" spill control pillows to soak up the puddles of fuel along the periphery of the tank. (These spill control pillows, replaced as needed around the tanks, are filled with inert foamed sand and adsorb acidic, caustic, solvent, and oil spills.) Photograph No. 5 shows the soiled spill control pillows around this minitank. Twenty-four hours later, a stream of diesel fuel was found escaping from this tank, as seen in Photograph No. 6. At this time, the tank was emptied to avoid environmental and safety hazards.

**Photograph No. 5. Soiled spill control pillows around E-2 minitank containing diesel fuel**

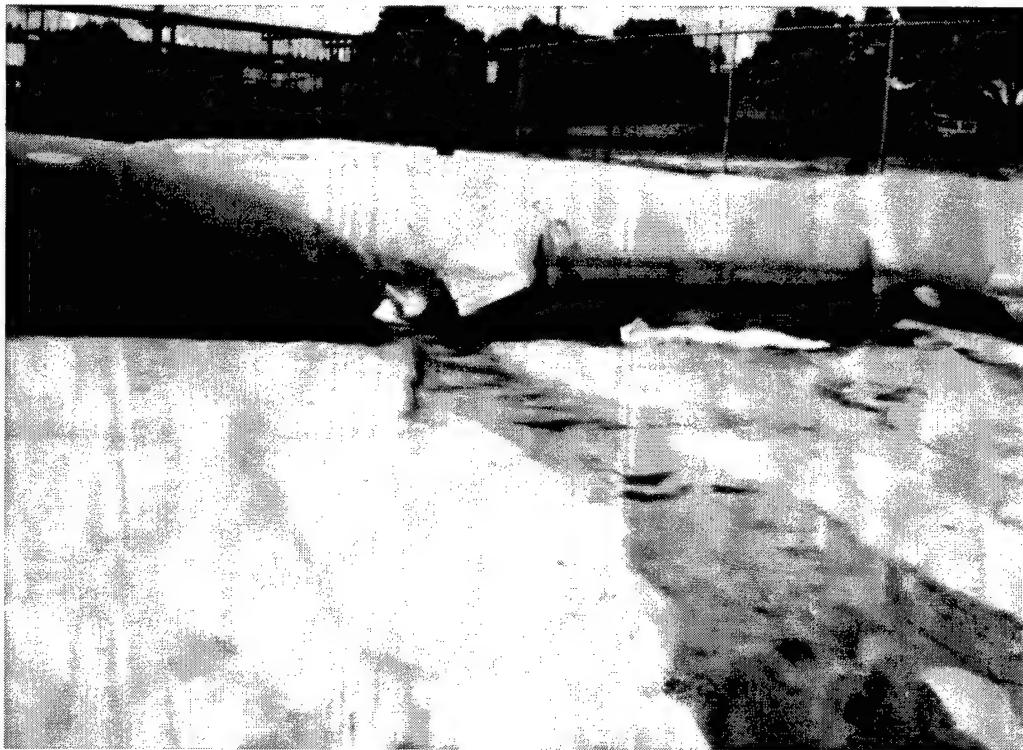
**Photograph No. 6. Diesel fuel leakage from E-2 minitank 24 hours after cleanup**

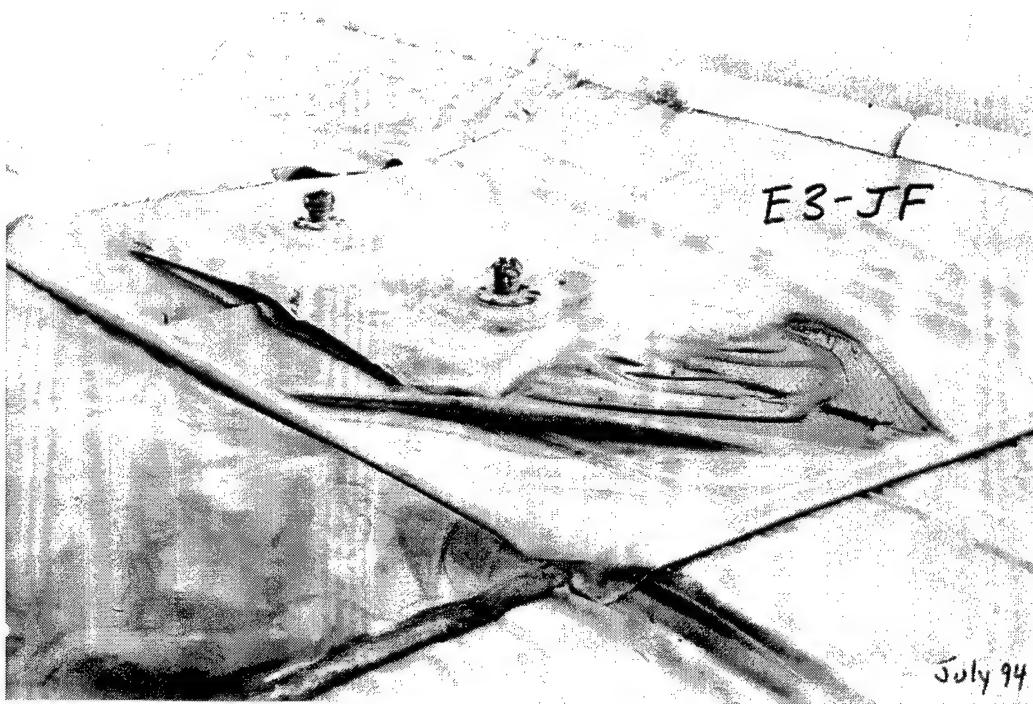
**E-3** minitank is shown in Photograph No. 7 immediately after it was filled with diesel fuel. Within two months of storage, this tank had to be emptied and withdrawn from further testing due to excessive fuel leakage at seam areas. Photograph No. 8 illustrates one such area. Minitank of E-3 is shown in Photograph No. 9 one day after it was filled with turbine fuel. Except for minor leaks from the seam areas, this tank survived for 22 months of outdoor exposure before it also had to be emptied of fuel due to an over 100-cm long fully separated seam section, as shown in Photograph No. 10. The empty tank was allowed to remain at the test site. Within one year after this picture was taken, most of the upper surface of this tank suffered from environmentally induced major delamination of the coating material from the nylon fabric, demonstrating full degradation of this material, as shown in Photograph No. 11.

**Photograph No. 10. Separated seam section of E-3 minitank containing turbine fuel after 22 months of outdoor exposure**

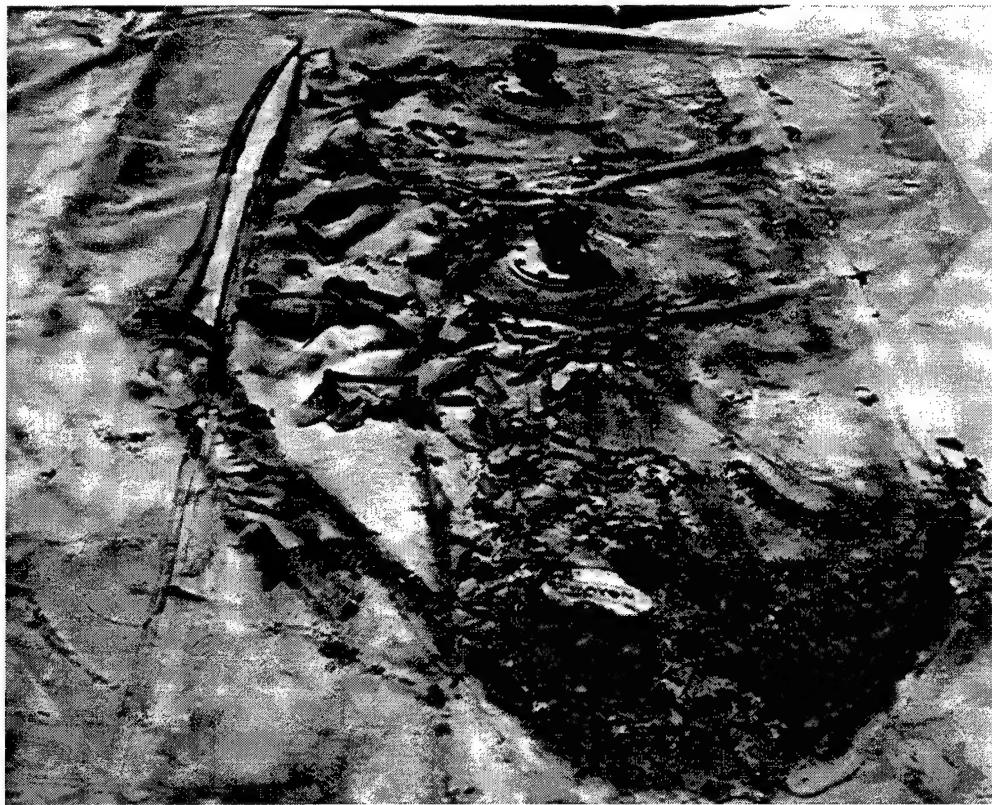
**Photograph No. 11. Full degradation of E-3 minitank containing turbine fuel**

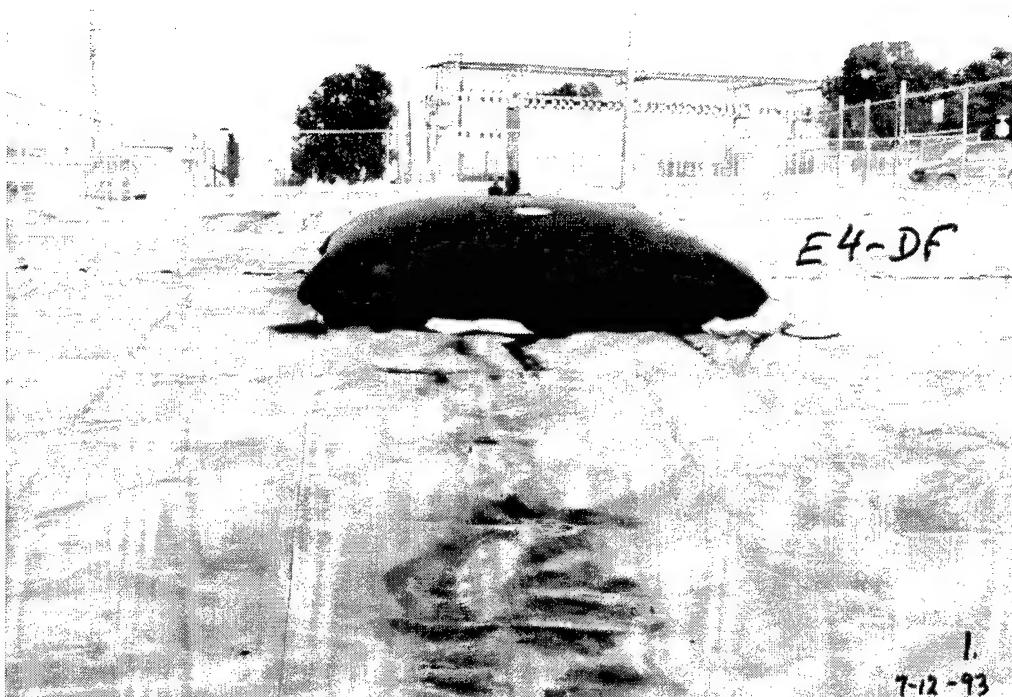
**E-4** minitank, filled with the referee grade diesel fuel during August 1992, is shown in Photograph No. 12. This tank failed after 10 months of exposure and had to be taken out of service due to excessive leaking from seam and corner areas, as shown in Photograph No. 13. Note the severe darkening of the outer surfaces of this tank.

**Photograph No. 13. Evidence of seam and corner leakage from E-4 minitank containing diesel fuel**
